TEST REPORT

Project Title: On Site Slip Resistance Testing of Grip top D400 Access Covers

Client: Saint Gobain PAM UK

Report Date: 21 May, 2012

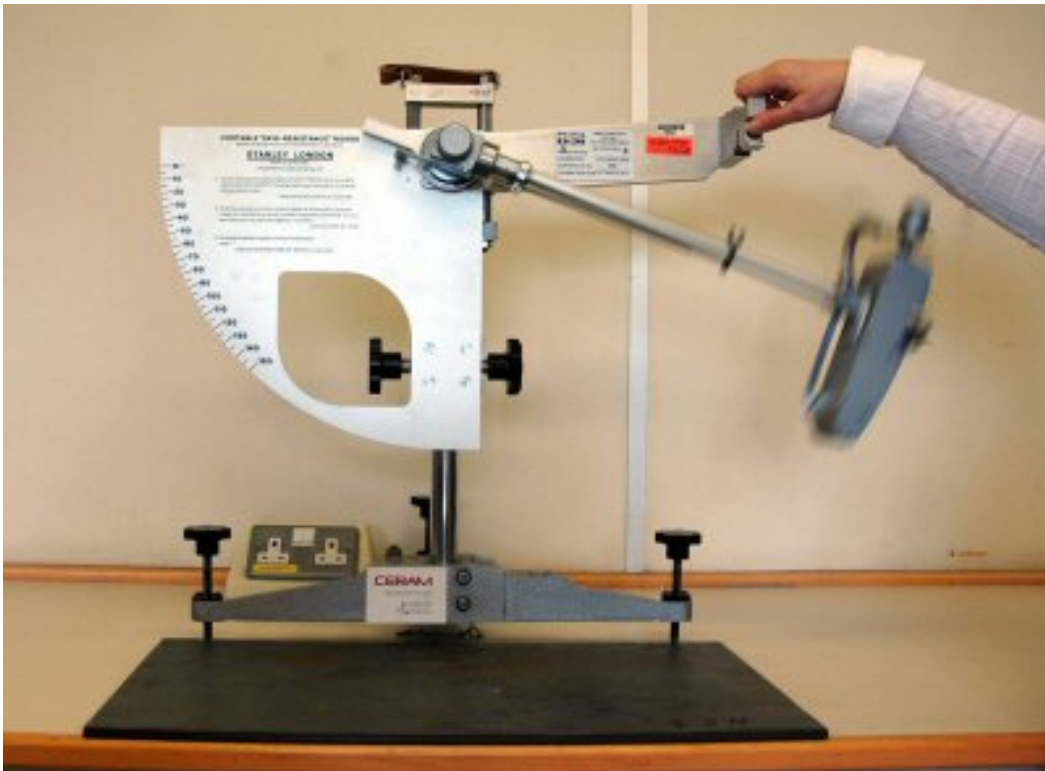
Pendulum Test Apparatus

All testing was carried out using the pendulum apparatus and the test method was based on that in BS 7976:2002 and BS EN 13036-4:2011. The apparatus is shown in the Appendix. This apparatus and test method is strongly recommended by the Health and Safety Executive and such a test would be carried out by them in the event of a skid or slipping accident.

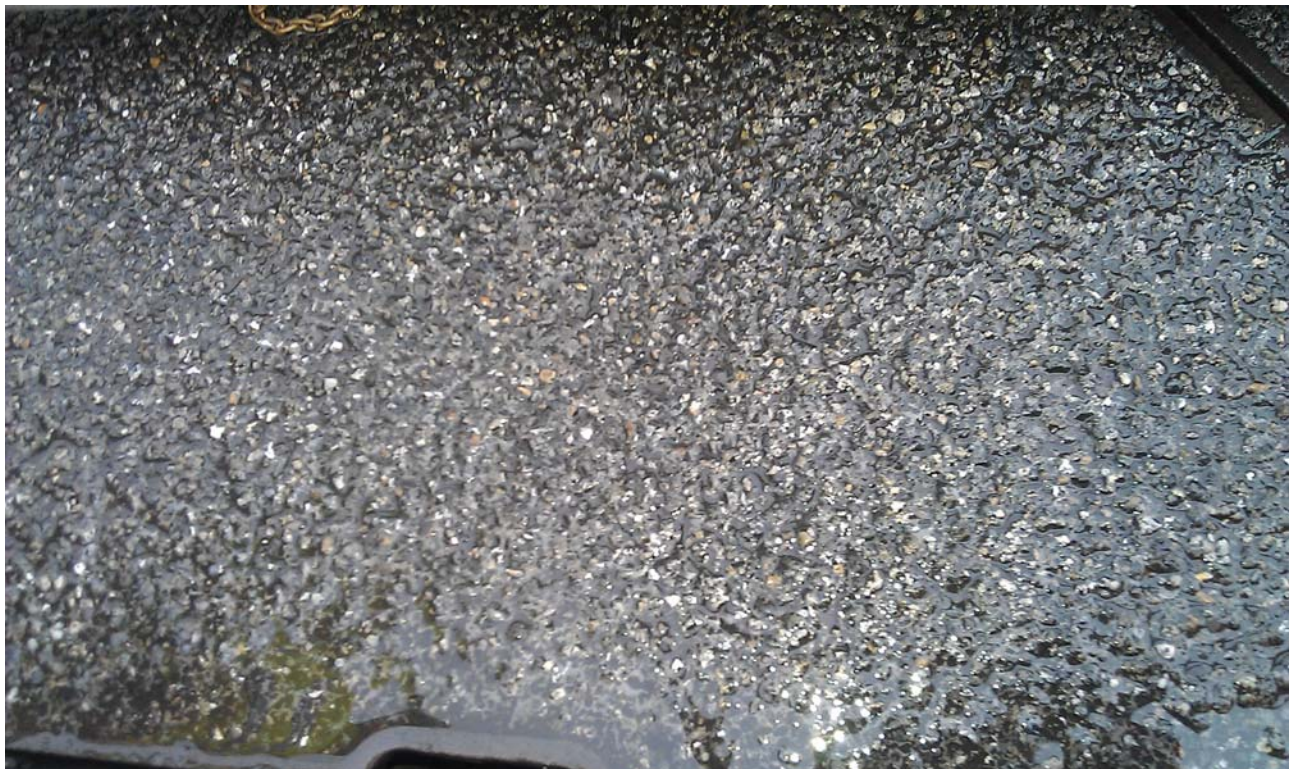
Test Surface

All of the covers tested were found to have a low potential for both skidding and slipping. The values obtained were in excess of the 55 recommended by the Design Manual for Roads and Bridges (DMRB) as a minimum for high risk situations and were also in excess of the 36 required by the HSE as a minimum for pedestrian safety.

The covers have maintained their slip resistant characteristics with little or no deterioration over the 5 year period of service.

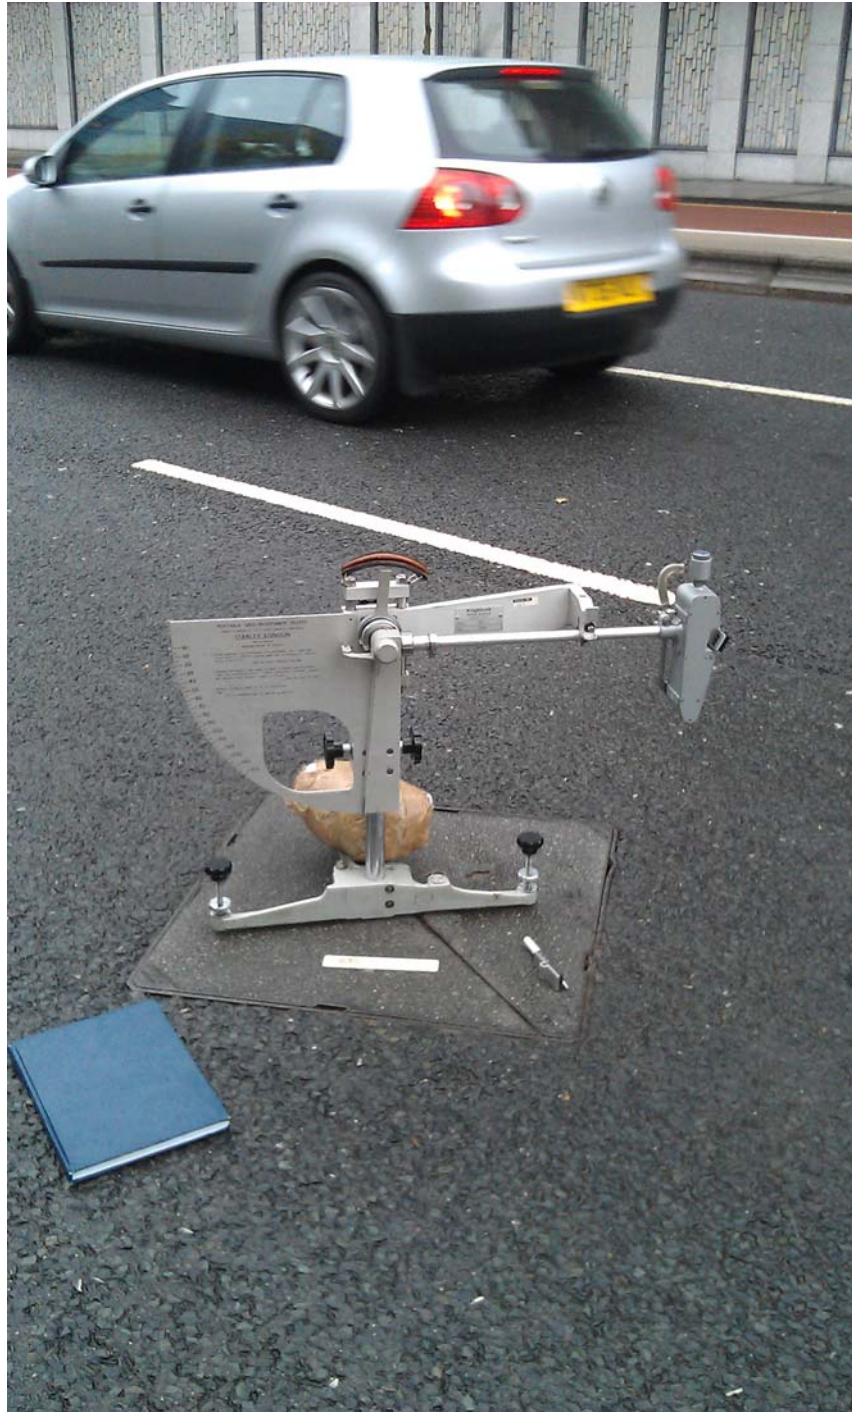
Example of Test Location
