Creating value through collaboration

Reducing whole life costs through the adoption of best practice

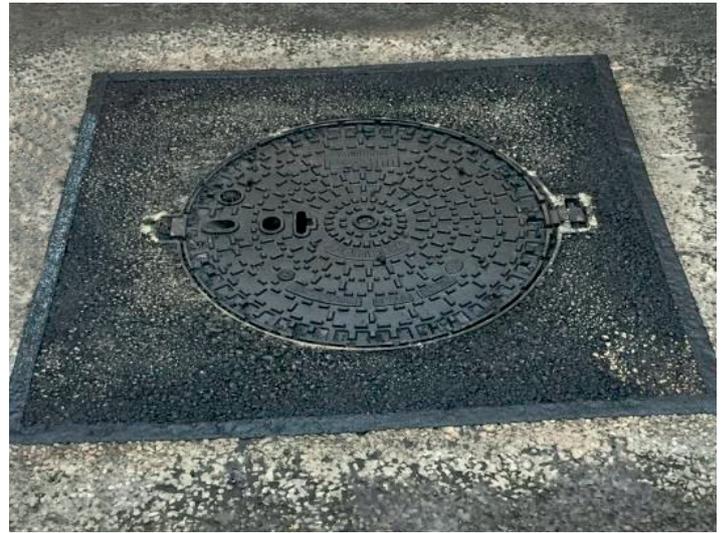
The supporting structure and chamber were in poor condition, it was also evident that the bedding materials used had failed.

Closer inspection determined a lack of support under the ironwork in critical functional areas.

Evidence of the incorrect type and amount of material needed to ensure a durable installation.

Working alongside the client the Saint-Gobain PAM UK team identified the need to combine the adoption of high performance products installed using best practice right first time installation techniques all governed by a robust, definitive specification. Pivotal to this was the use of the innovative Pamrex D400 access cover which features an integral elastomer gasket between the cover section and the frame. The gasket ensures silence in operation while also absorbing >60% of the shock and dynamic forces generated by traffic that would usually be transmitted into the bedding material and sub-structure thus increasing the durability and longevity of the overall installation.

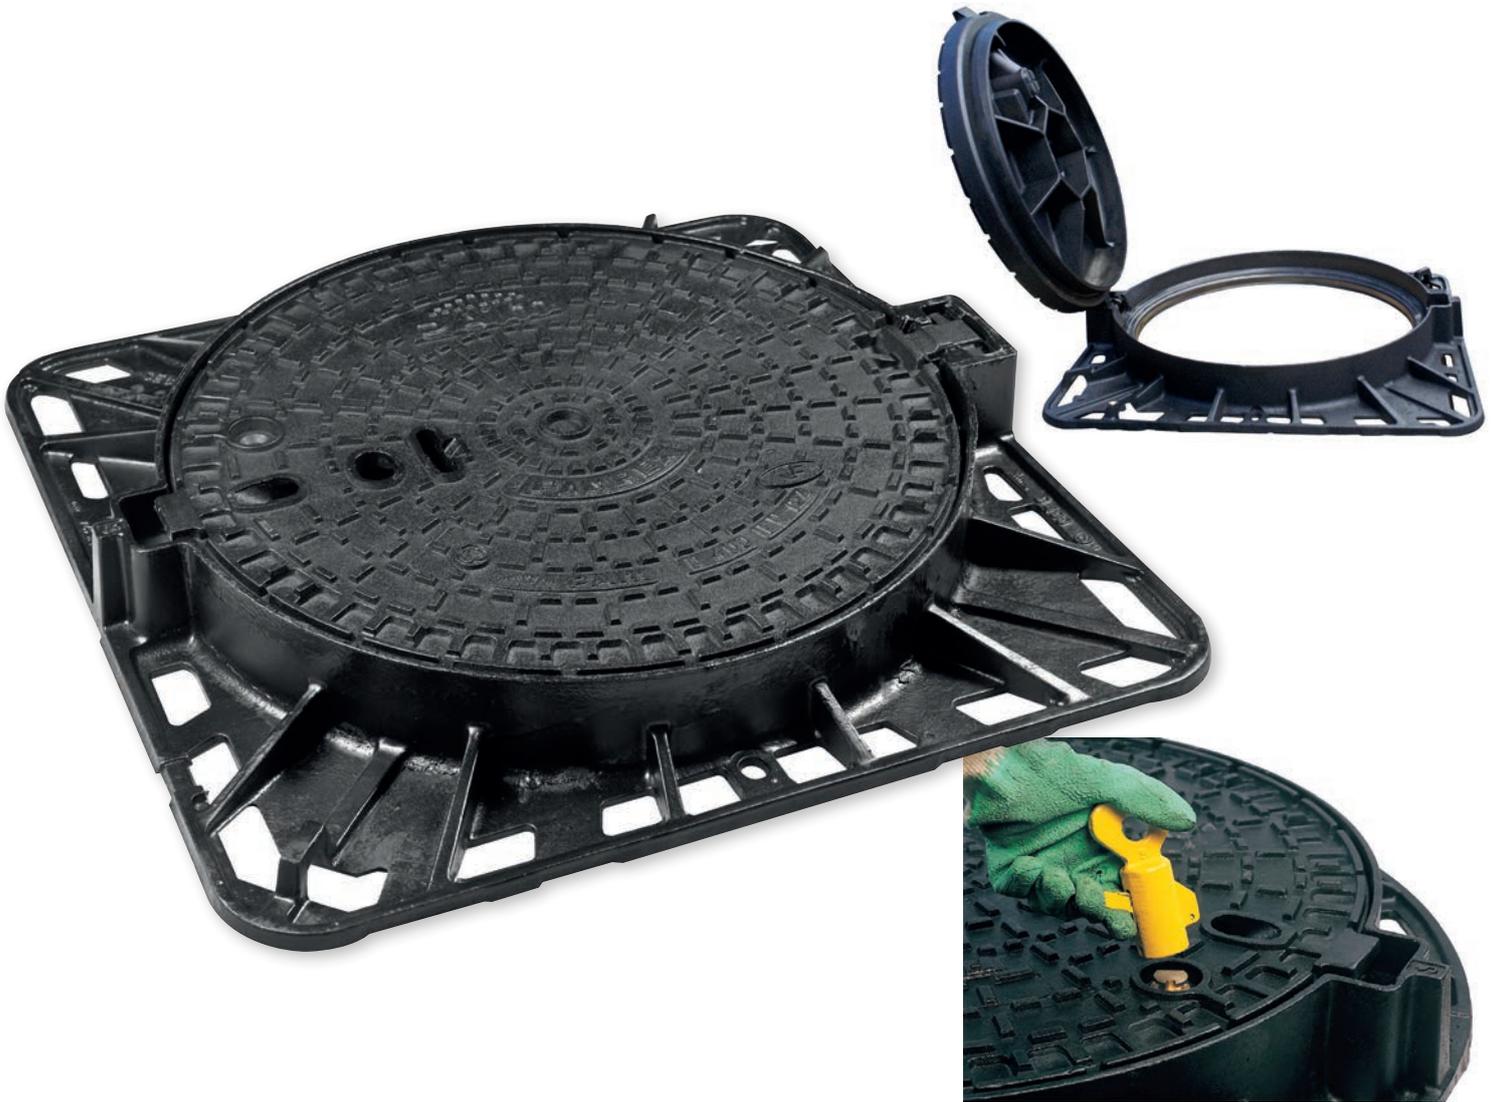
Pamrex is a versatile solution and offers many other benefits in relation to operator safety, security and the ability to minimise the ingress of surface water and control the egress of water in surcharge conditions.
